DUNDRUM CENTRAL MENTAL HOSPITAL

Perimeter Wall Condition Report

**DUNDRUM CENTRAL SHD
PERIMETER WALL
Condition Report**

Issued 14/03/2022

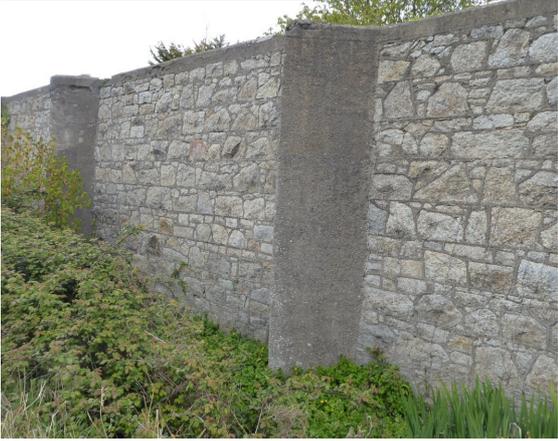
Feature	Image
<p>Buttresses</p> <p>In a number of extended sections (refer to drawings) the wall has internal buttresses at c. 7m intervals. These are composed of an in-situ concrete core containing large aggregate and rendered with a harled (wet-dash) finish.</p>

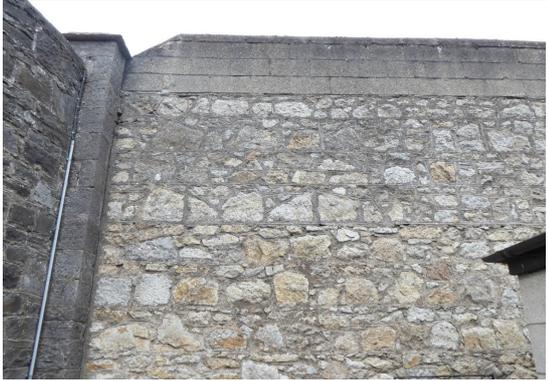
<p>Height extensions</p> <p>Between 45m and 60m a section of wall has been extended upwards in concrete blocks by some 600mm.</p>

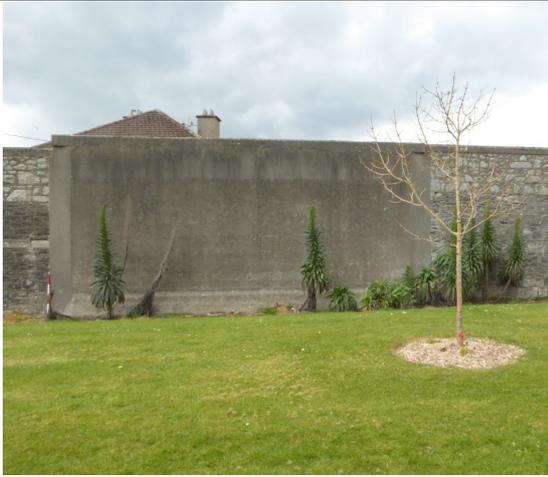
<p>Concrete faced/rendered section</p> <p>Between 1300m and 1315m a section of wall has been built-out and rendered in a cement-based render. The outside face at this location is in coursed rubble stone and shows signs of there having been an opening present or formed at some point in the past.</p>

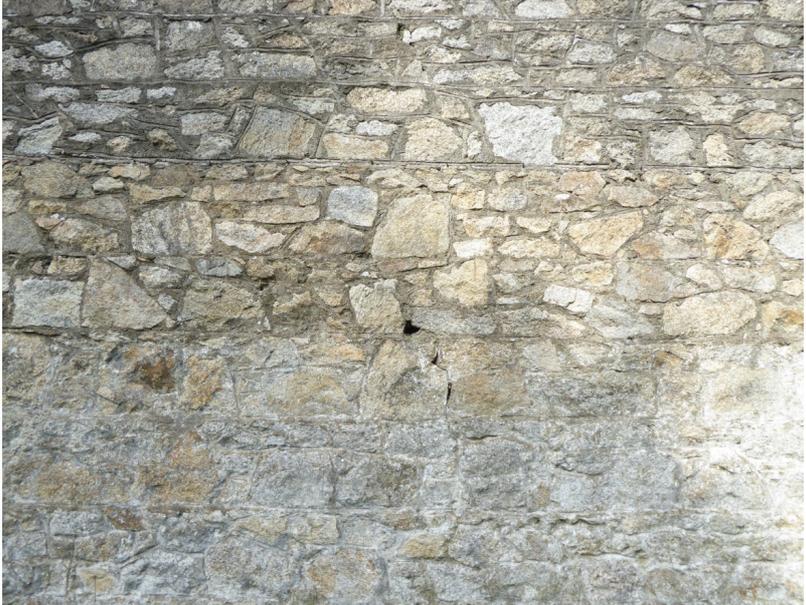
Attribute	Assessment overview
Missing/loose masonry	Incidences of missing and/or loose masonry on the inner face of the wall are very few, and in those instances noted are limited to a small number of stones. At no point on the inner face of the wall are there any points where the integrity or stability of the facing is a cause for concern.

<p><i>Typical example of the very minor masonry defects</i></p>
<p>Plumbness</p>	<p>The vast majority of the inner face of the wall measures as being plumb to within +2/-0 degrees off vertical, with + indicating an outward lean or batter. The maximum measured lean/batter noted was +5 degrees, and this over a limited section. In summary, the plumbness of the wall is overwhelmingly good and does not point to any concerns with its underlying stability.</p>
<p>Condition of bedding and pointing mortar.</p>	<p>The inner face of the wall has been comprehensively re-pointed in cement-based ribbon pointing at some stage since construction, though the weathering indicates that this took place some significant time ago. Failure of the pointing has occurred in small sections, these being uniformly distributed. Failure and loss of this pointing will continue, exposing the bedding mortar and eventually leading to loosening of masonry.</p>

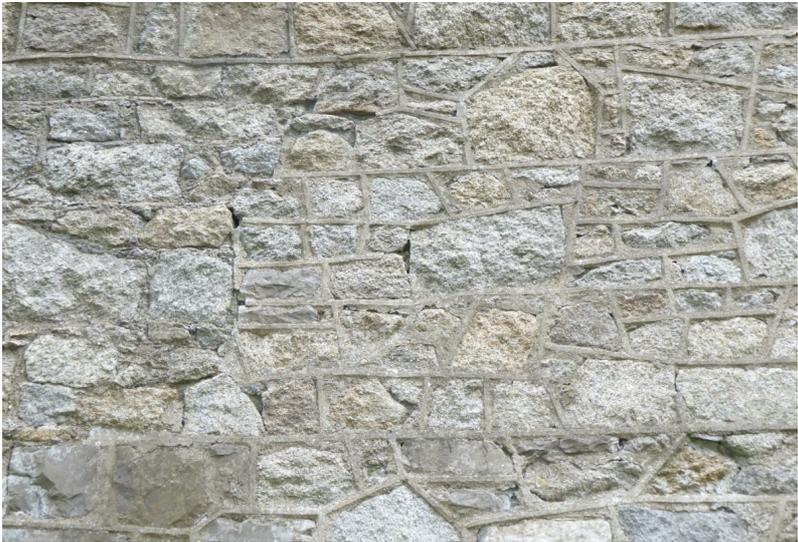
<p><i>Representative section illustrating loss of ribbon-pointing</i></p>

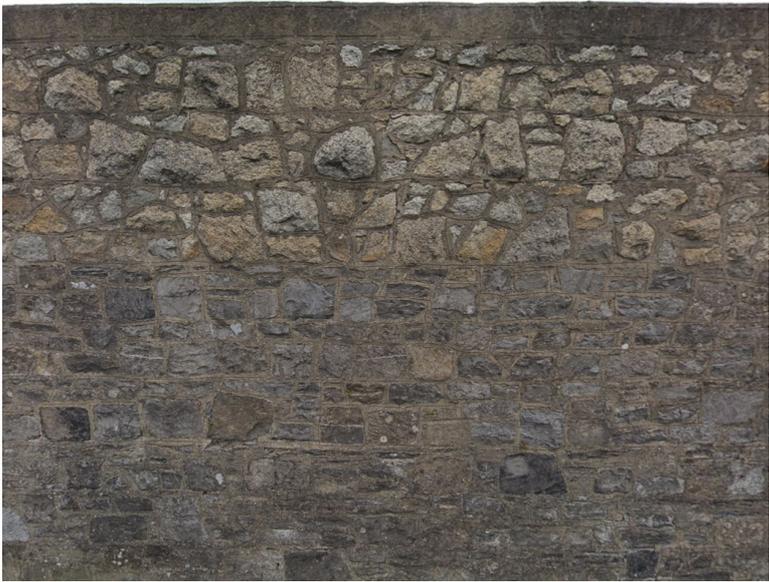
<p>The pointing on the external face of the wall has been similarly renewed at some time since construction, though not as consistently or latterly to the same high standard. Weathering and deterioration is slightly more pronounced than on the inside face, doubtless due to a more relaxed attitude to growth of vegetation on the outside face, but widespread/serious failure is not evident.</p>

<p><i>External pointing,</i></p>
--	--

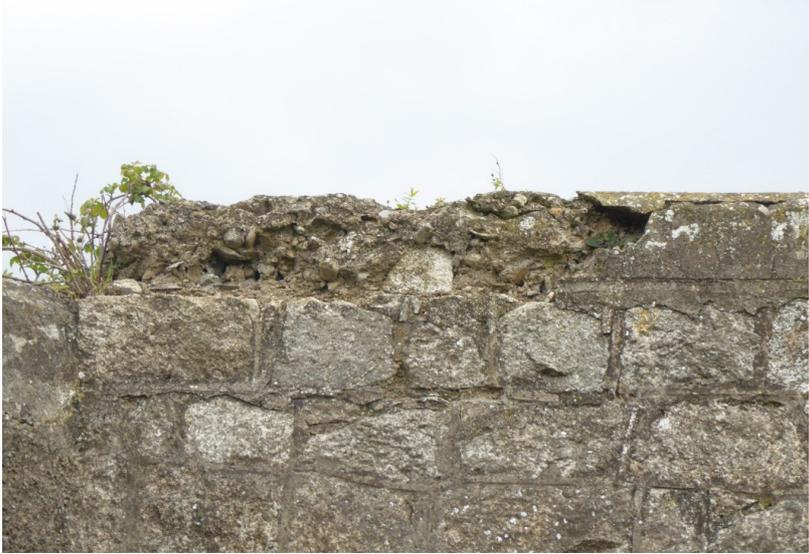
<p>Condition of copings</p>	<p>Coping condition is generally good, with failure being limited to those sections where the coping has been poured in-situ and rendered. Loss of the render has exposed the core and deterioration has accelerated. Repair to the deteriorated sections should be undertaken as soon as possible to preclude further decay of the wall heads.</p>

<p><i>Example of deteriorated coping</i></p>
-----------------------------	---

The inside face of the wall has obviously benefitted from ongoing care and maintenance, and barring some minor deteriorations was observed to be in a good condition overall. Deteriorations to the copings where noted should be addressed, as the coping provides the needed protection to the wall-head at the most vulnerable point of the wall. Whilst the pointing is noted to be in good condition for a large majority of the wall, aging and failure of the cement-based pointing is evident. A program of renewing the pointing where failed would ensure the continued stability of the masonry, preventing erosion of the bedding mortar and loosening of stones, and also preventing the growth of invasive vegetation.

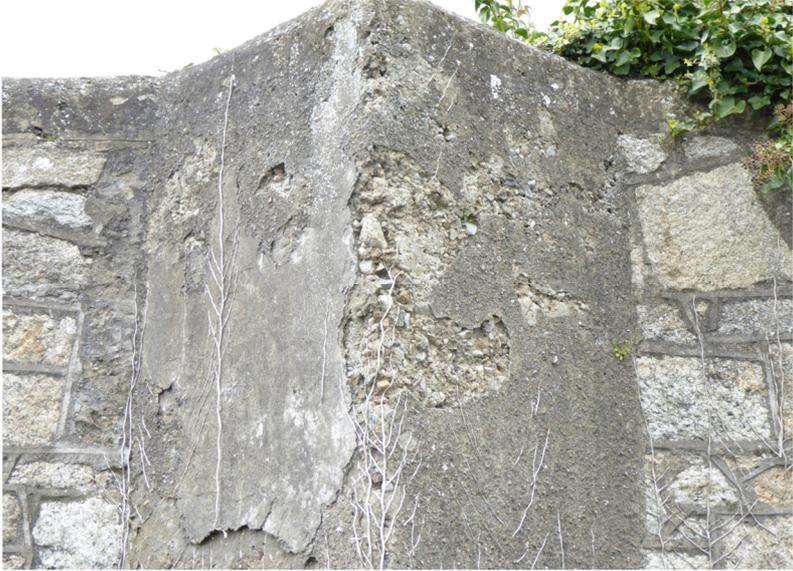
<p>Condition of render</p>	<p>Rendering to the wall is confined to the mass concrete buttresses. In a number of locations failure of this render has exposed the inner-core of the buttress. Render repairs should be carried out to protect the core of the buttresses from deterioration.</p>

<p><i>Example of deteriorated render</i></p>
<p>Invasive vegetation</p>	<p>Although there are areas of vegetative growth (mainly originating from the external face and progressing over the coping) there are no significant instances of invasive woody growth that might pose a risk to the structure of the wall.</p>

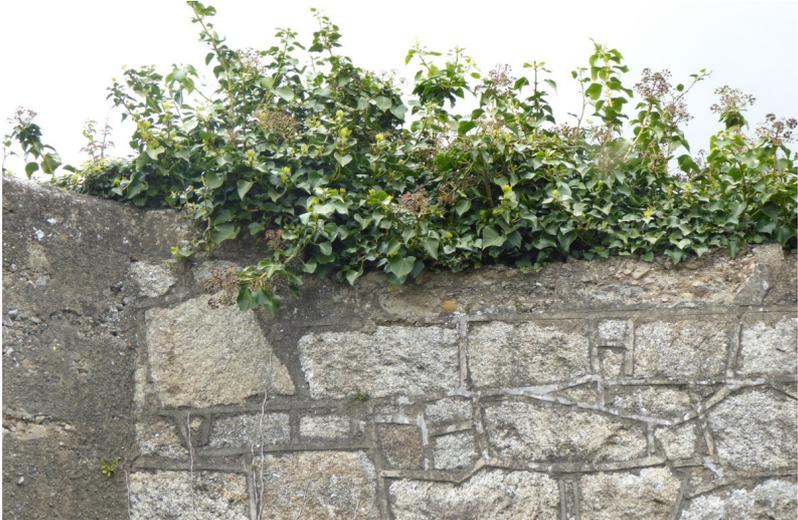
<p><i>Example of invasive vegetation encroaching from outside face of wall</i></p>
