DUNDRUM CENTRAL MENTAL HOSPITAL

Perimeter Wall Condition Report

**DUNDRUM CENTRAL SHD
PERIMETER WALL
Condition Report**

Issued 14/03/2022

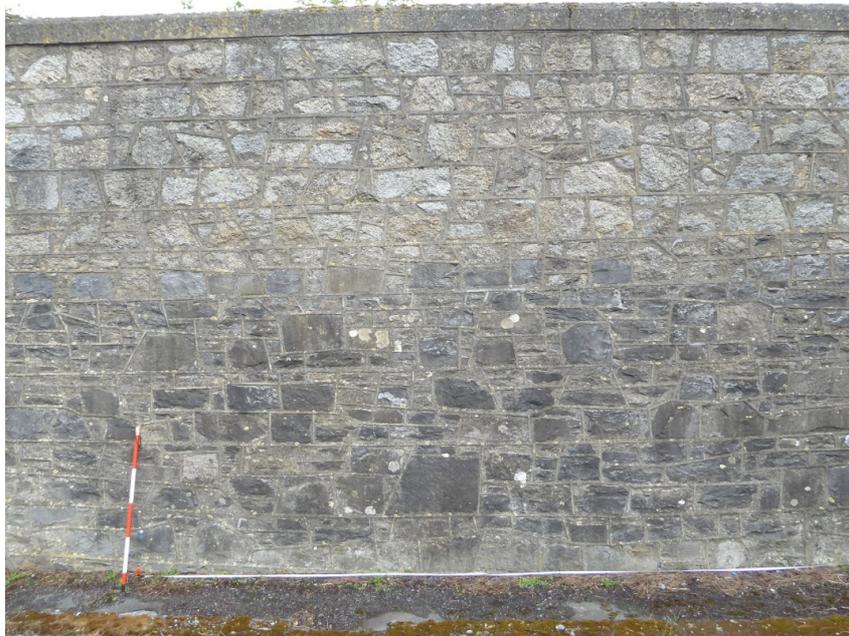
Figure 2 – Typical Wall Section

The wall is constructed in the main part from faced and roughly squared rubble granite blocks, with some sections being built in limestone blocks similarly sized and dressed. Stones are laid to courses, with each course being approximately 450mm. A typical section of walling is shown in Figure 2:

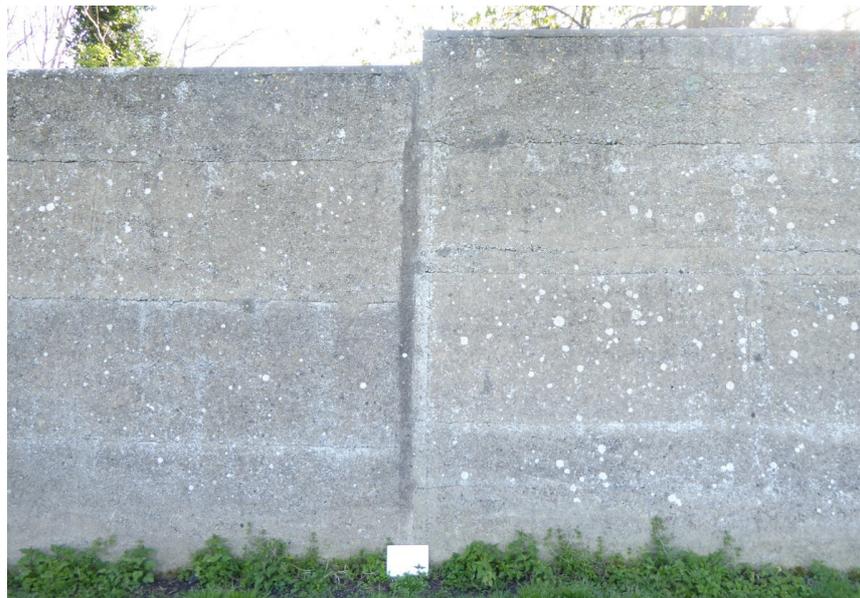
Figure 3 – Section of Wall in in-situ mass concrete

One contiguous section of walling is constructed from cast-in-situ mass-concrete, this being situated between 745m and 835m. A typical portion of this section is shown in Figure 3.

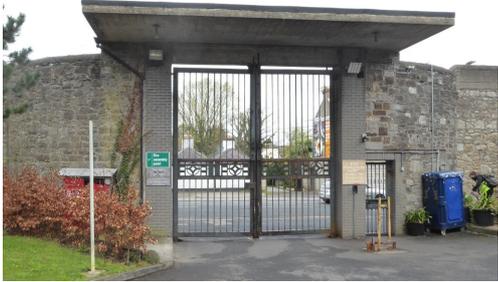
Distance Marker/Opening	Image
<p>0m Main vehicular entrance</p> <p>Brick piers with concrete canopy over. Metal vehicular gates with metal pedestrian gate to north.</p>

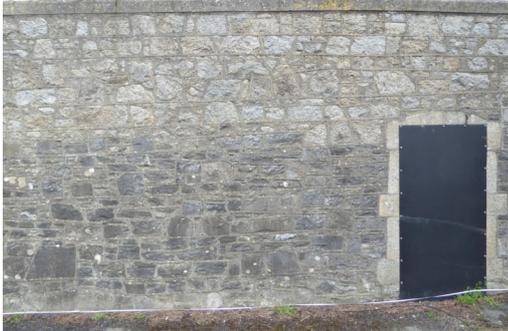
<p>170m Blocked pedestrian access</p> <p>Block and start granite jambs and granite voussoirs.</p>

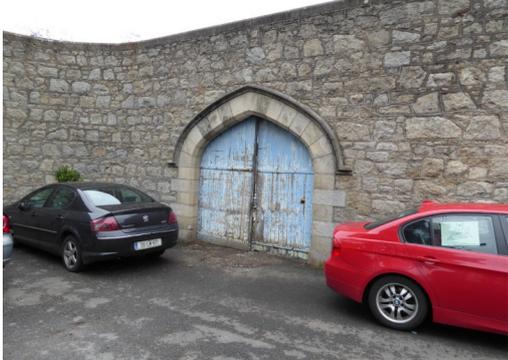
<p>259m Service yard vehicular access</p> <p>Jambs and voussoirs of four-pointed arch opening in ashlar granite blocks. Granite hood moulding. Painted timber gates.</p>

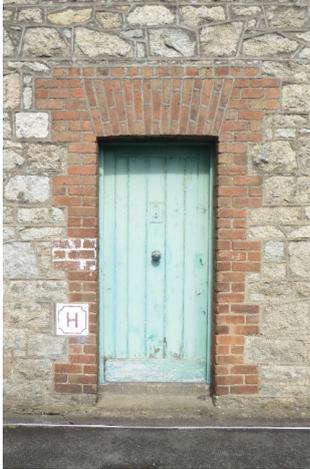
<p>270-300m Service yard pedestrian access</p> <p>Four pedestrian openings with brick dressings to jambs and flat brick arches over. Painted timber sheeted doors.</p>

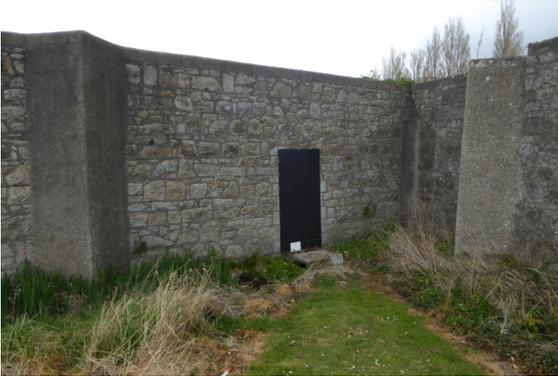
<p>527m Blocked pedestrian access.</p>

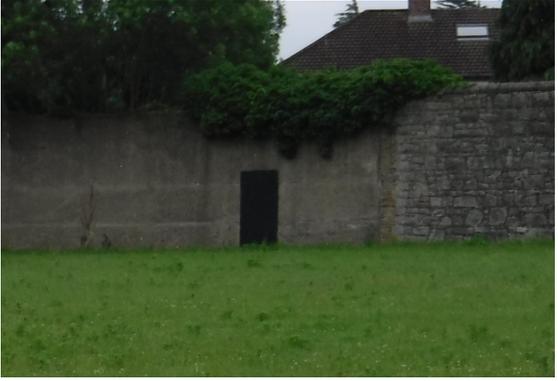
<p>830m Blocked pedestrian access.</p>

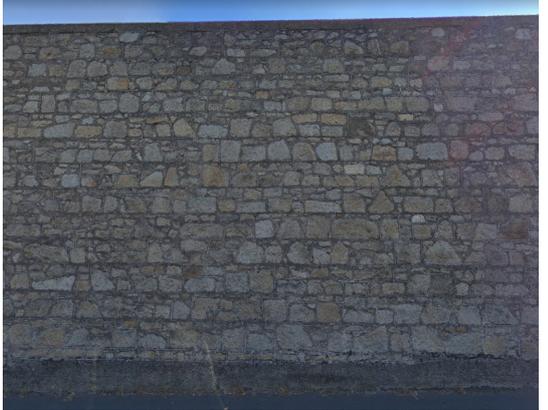
<p>Concrete foundation</p> <p>Sections of the wall (externally) on Dundrum Road were observed to be built on a mass-concrete foundation.</p>
